# ICE DAMS

Minnesota Department of Commerce Energy Information Center

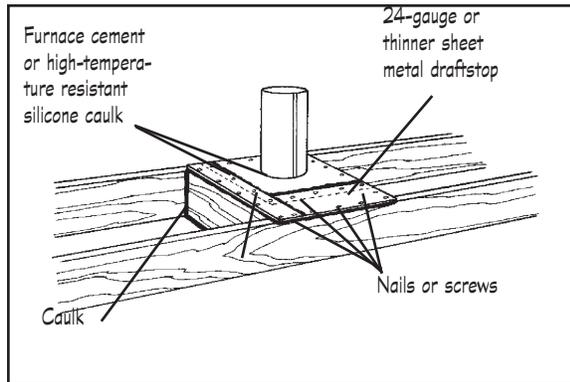
Figure 1  
With a metal chimney, the ceiling penetration can be closed with sheet metal sealed with long-life flexible caulk to the framing. Silicone caulk resistant to 400 degrees F. should be used to seal the sheet metal to the chimney.

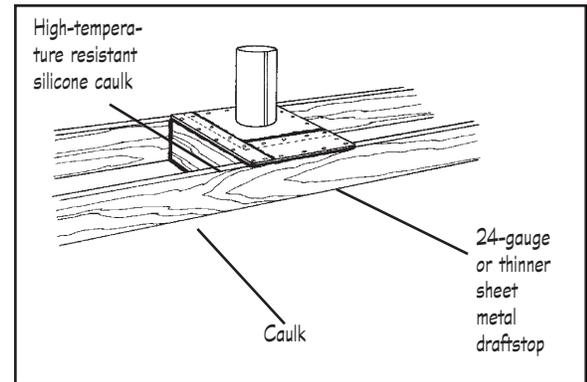
Figure 2  
Gaps between a brick chimney and the joists can be closed with sheet metal cut into halves to fit around the chimney and sealed the same way as with a metal chimney.

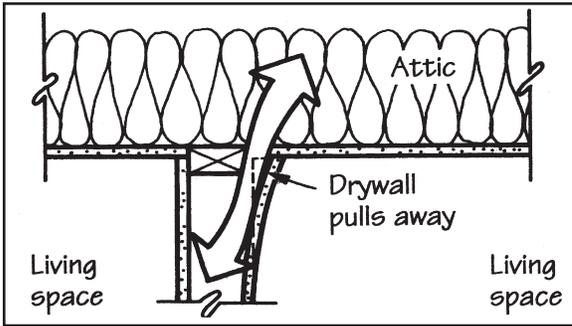
Above left: Leaks at wall-ceiling intersection. If the top plate shrinks and pulls away from the drywall, cold air will enter the partition and then the living space through openings such as electrical boxes. Prevent this by caulking the top plate. The same problem can also occur where an interior partition wall joins an exterior wall. Right: Cold wall-ceiling intersection at eaves may have mildew from condensation when insulation doesn't extend deeply enough into the eaves. Fix by extending batt far enough to completely cover the living space, but make sure to leave ventilation space below the roof sheathing.

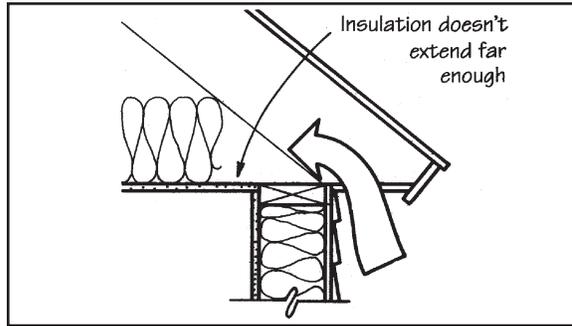
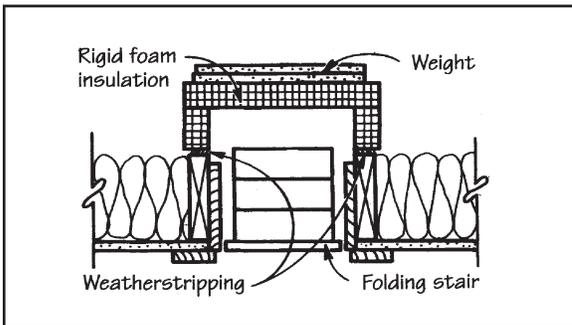
Above left: Attic bypasses occur when no air seal or insulation is placed over the folding attic stair. The best solution is a box made of rigid foam with a little weight on top (wallboard works well), with weatherstripping to seal it. Right: A gap below the kneewall in the second story is a common area of air leaks. Unless the joist space is blocked below the kneewall, warm air enters the crawl space. Block with rigid foam sealed with caulk.

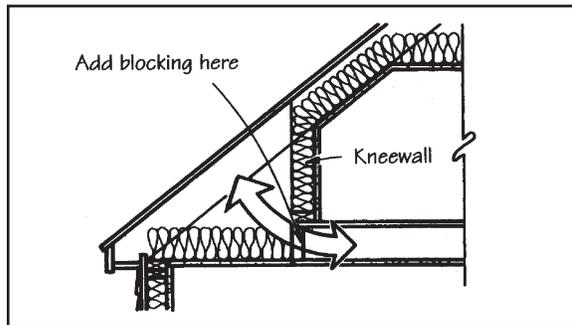
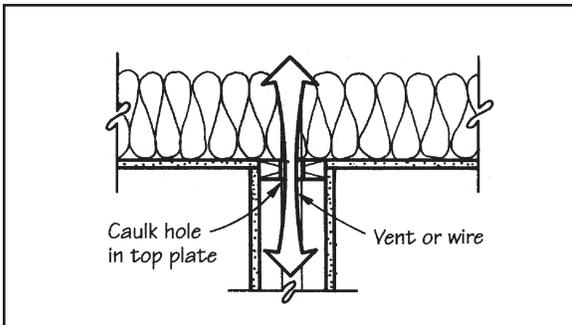
Above left: Leaks around plumbing vents and wiring is a frequent problem. Fix by caulking or foaming around openings in the top plate or using rubber boots that slip around pipes or chases. Right: Unsealed kitchen or bath soffits are all too common. A soffit is hung from the framing with no wallboard at ceiling level to seal the insulation. Seal with plastic under the ceiling insulation. This may be hard to retrofit, but it's a major problem.

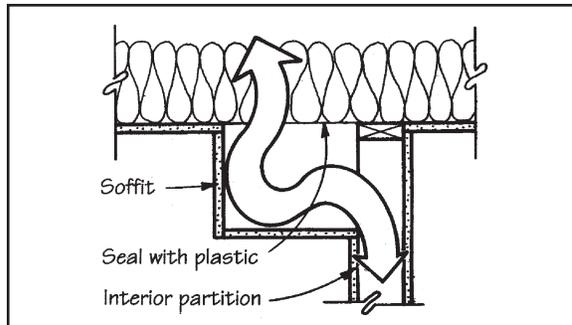
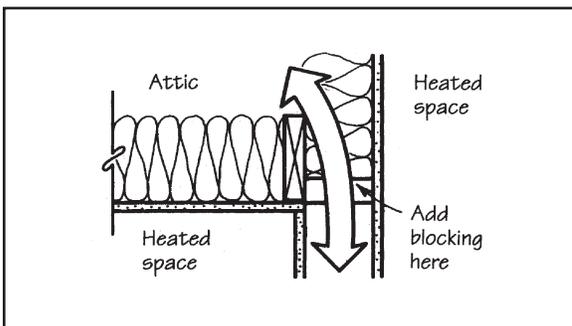
Above left: Unblocked stud bay to attic in split levels, similar to a problem in balloon framing, where stud bays continue past ceiling joists to the attic. Block with rigid foam. Right: Recessed ceiling lights are tough to deal with, though some models offer good air sealing. For new recessed lighting, look for fixtures designed and tested for low leakage. For existing recessed lights, check the label for an "IC" (Insulation Covered) Rating. If it has an IC Rating, you can build an airtight enclosure
